Manhole Inspection Summary

Manhole # S13II_004MH

Insp Date: **2/23/09 3:45 PM**

Location Address: **REAR 2851 NORTH AVE**

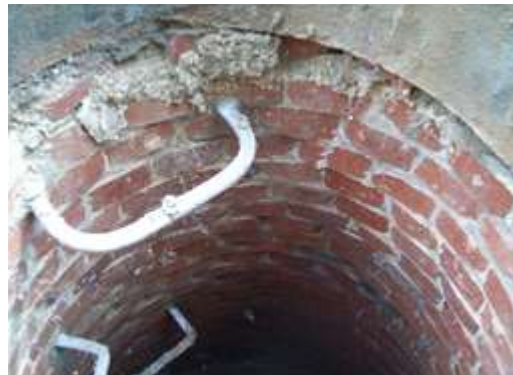
Defect 2

Condition: ☐ Sound ☒ **Cracked** ☐ Root Intrusion ☐ Loose Brick ☐ Deteriorated

Steps Count: **8** Missing: **0** ☒ **Corroded**

cracked corbel and corroded steps

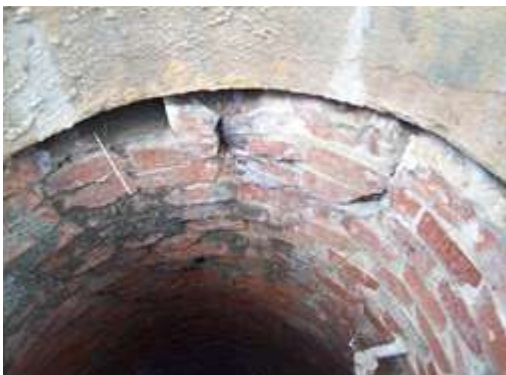
Defect 1

Condition: ☐ Sound ☒ **Cracked** ☐ Root Intrusion ☐ Loose Brick ☐ Deteriorated

cracked chimney

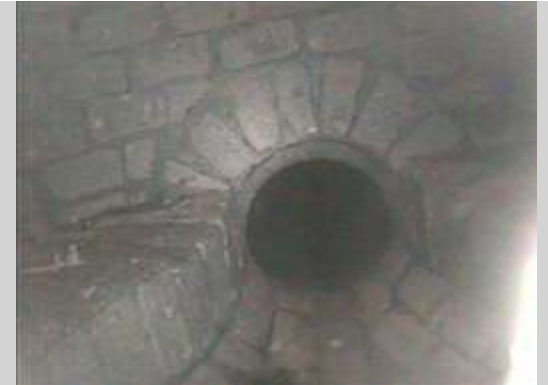
12 O'Clock Outflow

8 in. Circular Gravity Sewer
Pipe Out @ 12 O'Clock

Invert Depth: **11.37** (ft.) Flow Characteristics: **Slow**

Infiltration: **None** Pipe Seal Cond: **Sound**

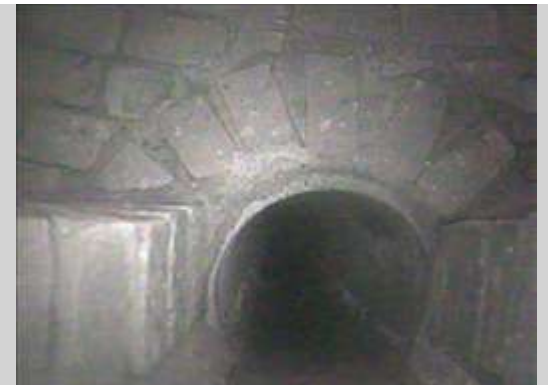
3 O'Clock Inflow

8 in. Circular Gravity Sewer
Pipe In @ 3 O'Clock

Invert Depth: **11.44** (ft.) Flow Characteristics: **Slow**

Infiltration: **None** Pipe Seal Cond: **Sound**

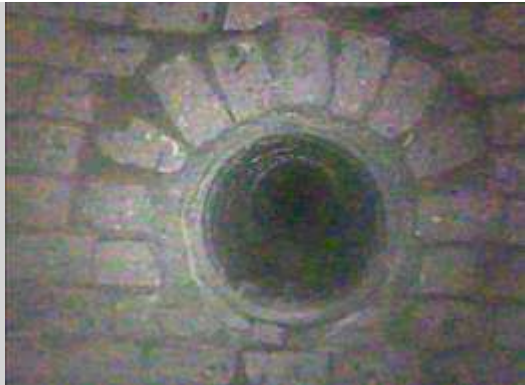
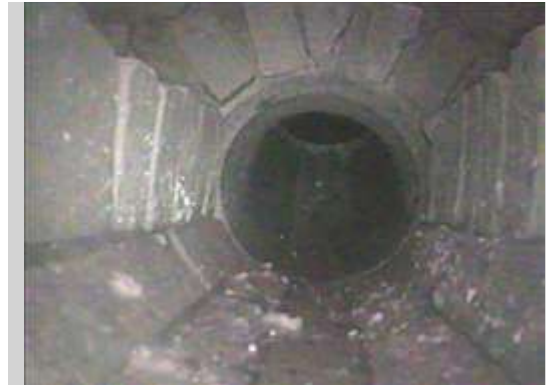
6 O'Clock Inflow

Pipe In @ 6 O'Clock

Drop In @ 6 O'Clock

Infiltration: **None** Pipe Seal Cond: **Sound**

Drop: **Outside Direct**

Drop Condition: **Open**

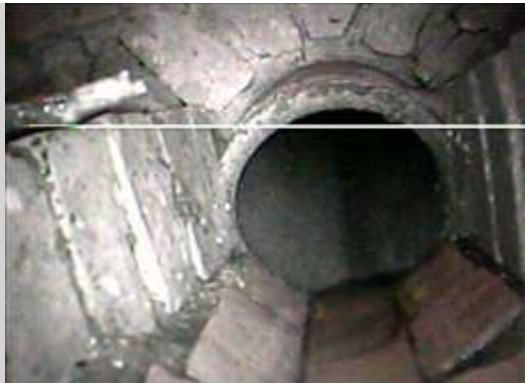
9 O'Clock Inflow

Pipe In @ 9 O'Clock

Infiltration: **None** Pipe Seal Cond: **Sound**

Connects To: **House connection / Service line**
